Juniper Networks ScreenOS Release Notes

Products: NetScreen Hardware Security Client, NetScreen-5XT, NetScreen-5GT, NetScreen-5GT Wireless (ADSL), NetScreen-5GT ADSL, NetScreen-25, NetScreen-50, NetScreen-204, NetScreen-208, NetScreen500, ISG 1000, ISG 2000, NetScreen-5200, and NetScreen-5400

Version: ScreenOS 5.3.0r6

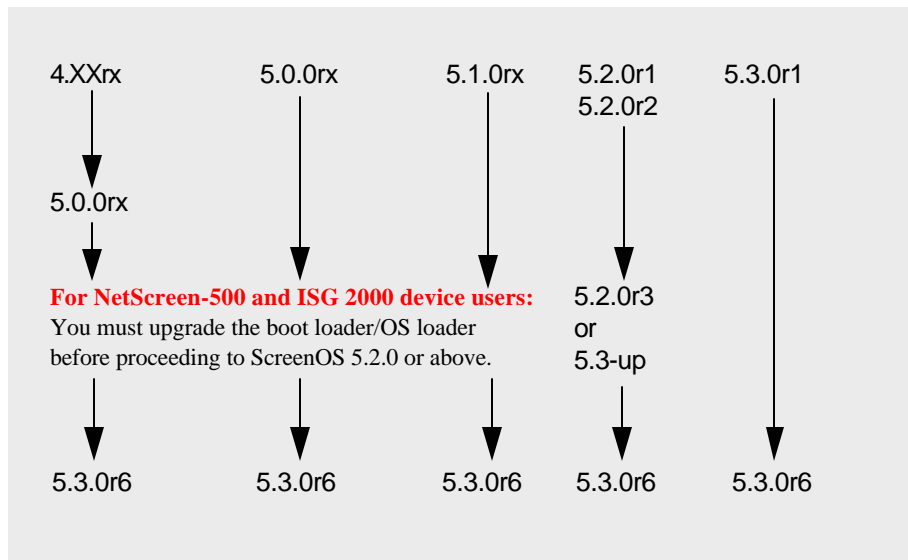
Figure 1. Firmware Upgrade Path

Figure 1 shows the firmware upgrade path.

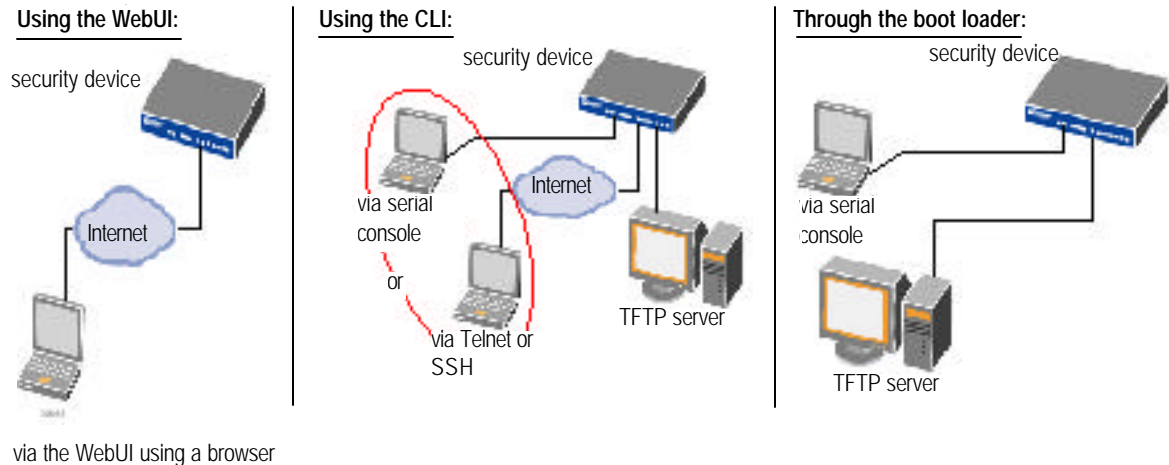
Figure 2. ScreenOS Upgrade and Downgrade Methods

Error! Reference source not found. illustrates the three different ways by which you can upgrade or downgrade a security device.

Note: For NetScreen-500 and ISG 2000 devices, you can upgrade or downgrade only through the boot loader.
