Juniper Networks ScreenOS Release Notes

Release 5.4.0r17
June 2010
Revision 02

Products: NetScreen-5GT Series, NetScreen-25, NetScreen-50, NetScreen-200 Series, NetScreen-500, and NetScreen-5000 Series (NetScreen-5200 and NetScreen-5400 with MGT or MGT2 modules and 2G24FE or 8G SPM).

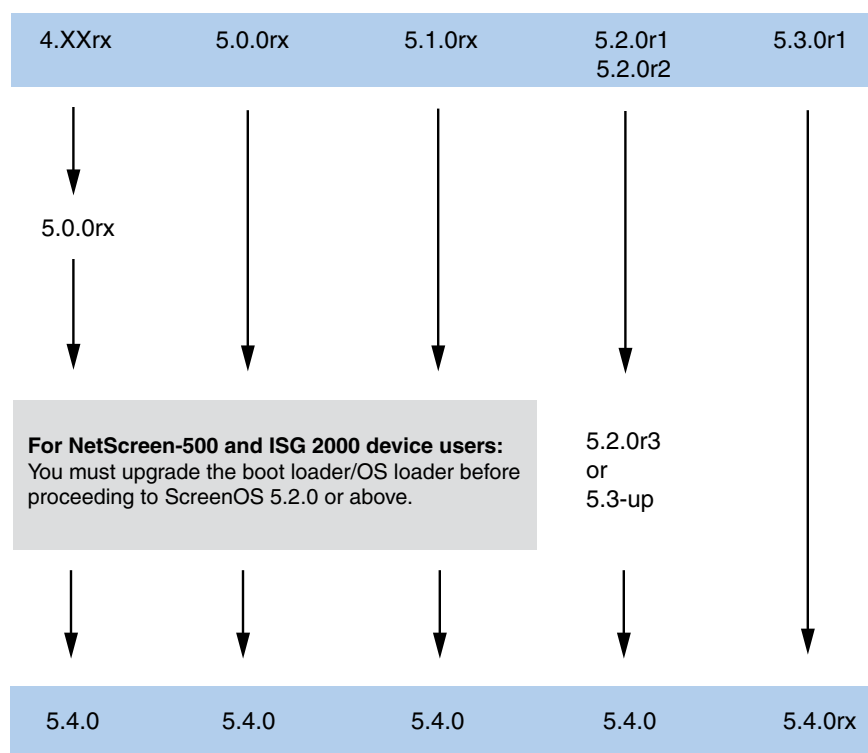
Figure 1: Firmware Upgrade Path

Before you upgrade a security device, you must have the most recent ScreenOS firmware stored on your local drive. Depending on the platform and the firmware your security device is currently running, you also might need intermediate (or step-up) firmware and/or new boot loader firmware. Firmware Upgrade Path illustrates the various firmware upgrade paths to ScreenOS 5.4.0.

Figure 1 on page 20 lists the recommended upgrade path to ScreenOS 5.4.0 based on device model and firmware version. For example, if you are running ScreenOS 4.0 on a NetScreen-204, you need to upgrade to ScreenOS 5.0r10 or later before upgrading to ScreenOS 5.4.0. If you are running ScreenOS 5.1 on a NetScreen-204, however, you can upgrade directly to 5.4.0. Upgrade Paths to ScreenOS 5.4.0 also lists memory and boot loader upgrade requirements for each ScreenOS version and platform.

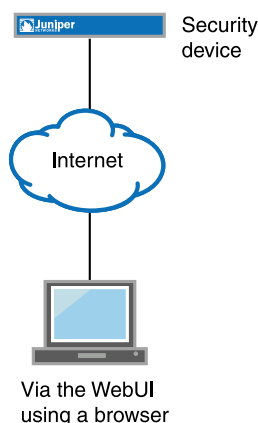
Using the WebUI

ScreenOS Upgrade and Downgrade Methods illustrate the three different ways by which you can upgrade or downgrade a security device.

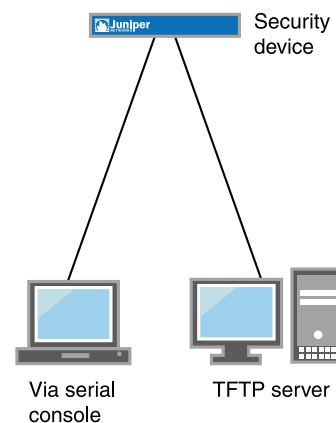
Through the boot loader

NOTE: For NetScreen-500 and ISG 2000 devices, if a boot loader upgrade is required, you must upgrade using the boot loader.
