Juniper Networks ScreenOS Release Notes

Release 5.4.0r22
August 2011
Revision 01

Products: NetScreen-5GT Series, NetScreen-25, NetScreen-50, NetScreen-200 Series, NetScreen-500, and NetScreen-5000 Series (NetScreen-5200 and NetScreen-5400 with MGT or MGT2 modules and 2G24FE or 8G SPM).

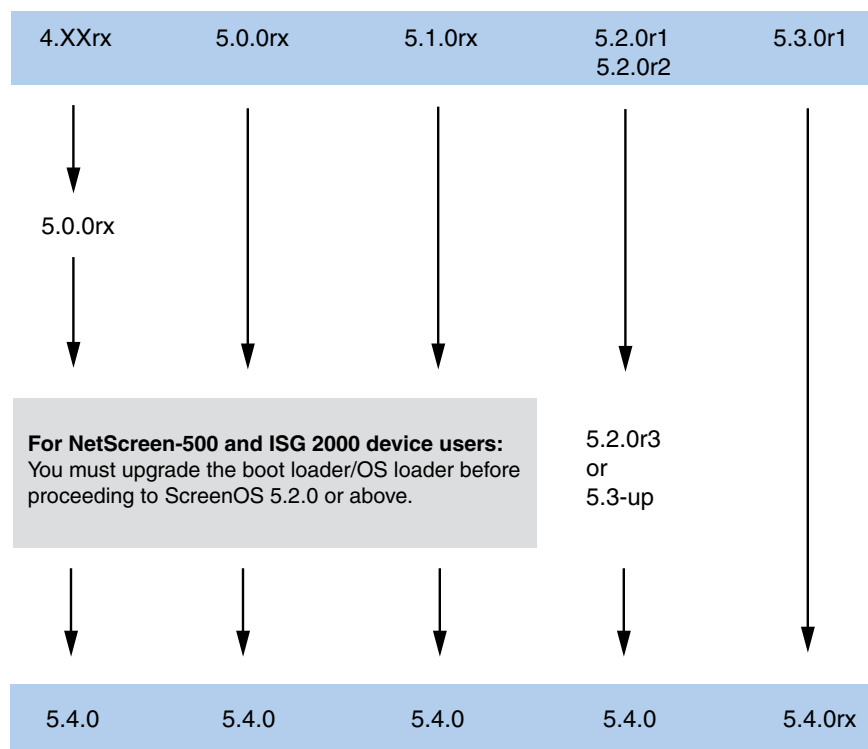
Figure 1: Firmware Upgrade Path

Before you upgrade a security device, you must have the most recent ScreenOS firmware stored on your local drive. Depending on the platform and the firmware your security device is currently running, you also might need intermediate (or step-up) firmware and/or new boot loader firmware. Firmware Upgrade Path illustrates the various firmware upgrade paths to ScreenOS 5.4.0.

Figure 1 on page 21 lists the recommended upgrade path to ScreenOS 5.4.0 based on device model and firmware version. For example, if you are running ScreenOS 4.0 on a NetScreen-204, you need to upgrade to ScreenOS 5.0r10 or later before upgrading to ScreenOS 5.4.0. If you are running ScreenOS 5.1 on a NetScreen-204, however, you can

upgrade directly to 5.4.0. Upgrade Paths to ScreenOS 5.4.0 also lists memory and boot loader upgrade requirements for each ScreenOS version and platform.

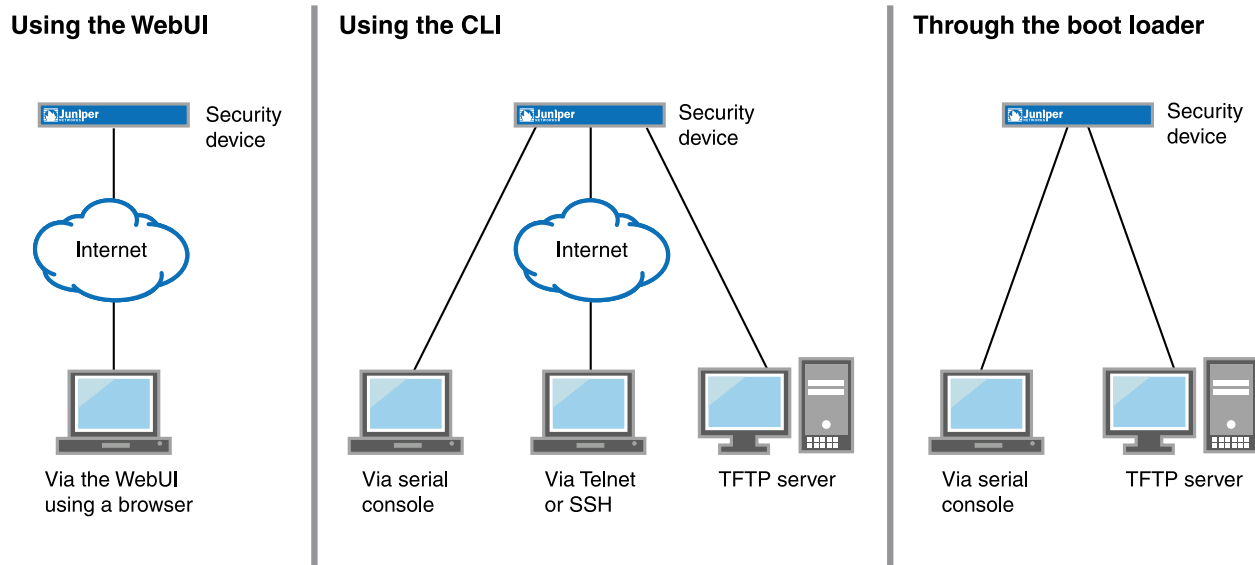
- Root or read-write privileges to the security device
- TFTP server installed locally that has an IP address in the same subnet as the security device (255.255.255.0)
- Ethernet connection from a computer to the security device (to transfer data, namely from a local TFTP server)
- Console connection from the computer to the security device (to manage the security device)
- New ScreenOS firmware saved to a local TFTP server directory

ScreenOS Upgrade and Downgrade Methods illustrate the three different ways by which you can upgrade or downgrade a security device.

NOTE: For NetScreen-500 and ISG 2000 devices, if a boot loader upgrade is required, you must upgrade using the boot loader.
