Juniper Networks ScreenOS Release Notes

Release 5.4.0r25
June 2012
Revision 01

Products: NetScreen-5GT Series, NetScreen-25, NetScreen-50, NetScreen-200 Series, NetScreen-500, and NetScreen-5000 Series (NetScreen-5200 and NetScreen-5400 with MGT or MGT2 modules and 2G24FE or 8G SPM).

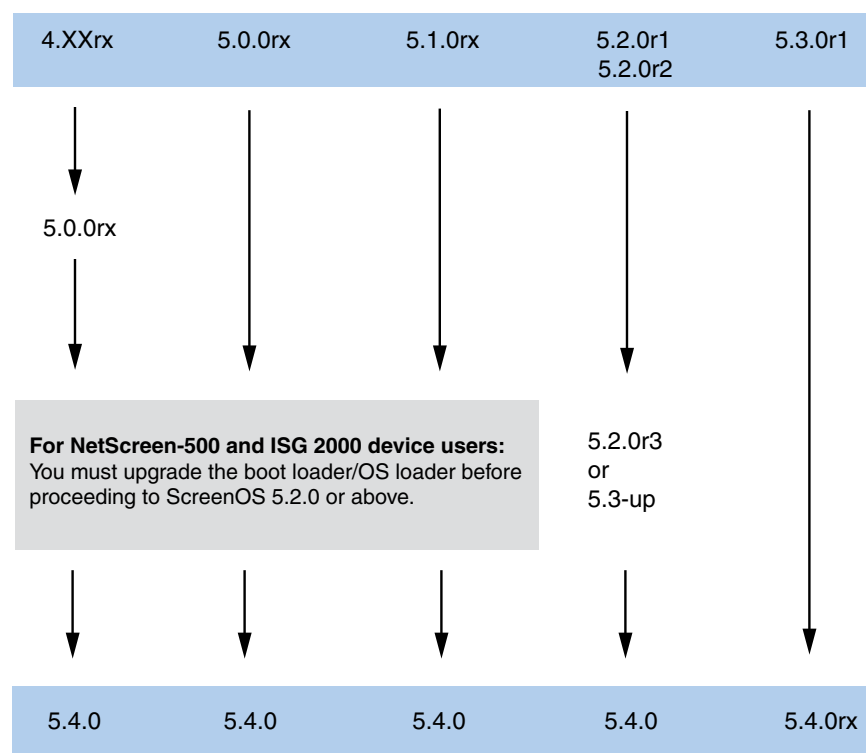
Figure 1: Firmware Upgrade Path

Before you upgrade a security device, you must have the most recent ScreenOS firmware stored on your local drive. Depending on the platform and the firmware your security device is currently running, you also might need intermediate (or step-up) firmware and/or new boot loader firmware. Firmware Upgrade Path illustrates the various firmware upgrade paths to ScreenOS 5.4.0.

Figure 1 on page 23 lists the recommended upgrade path to ScreenOS 5.4.0 based on device model and firmware version. For example, if you are running ScreenOS 4.0 on a NetScreen-204, you need to upgrade to ScreenOS 5.0r10 or later before upgrading to ScreenOS 5.4.0. If you are running ScreenOS 5.1 on a NetScreen-204, however, you can upgrade directly to 5.4.0. Upgrade Paths to ScreenOS 5.4.0 also lists memory and boot loader upgrade requirements for each ScreenOS version and platform.

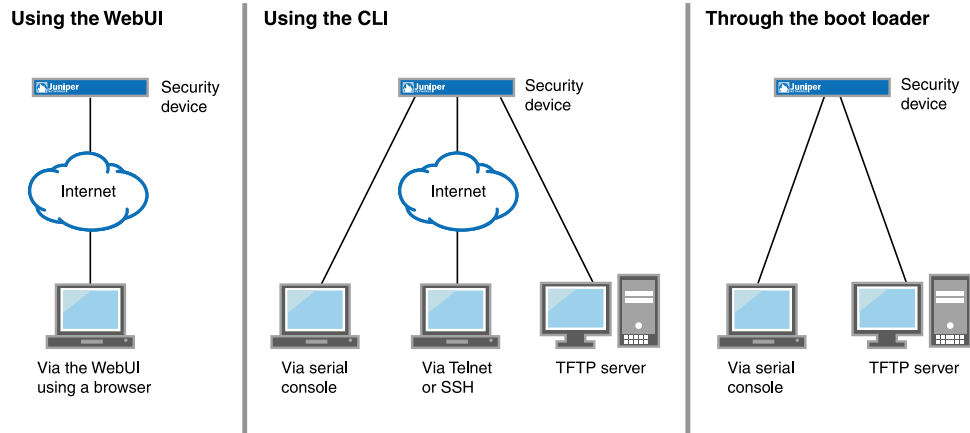
- Root or read-write privileges to the security device
- TFTP server installed locally that has an IP address in the same subnet as the security device (255.255.255.0)
- Ethernet connection from a computer to the security device (to transfer data, namely from a local TFTP server)
- Console connection from the computer to the security device (to manage the security device)
- New ScreenOS firmware saved to a local TFTP server directory

ScreenOS Upgrade and Downgrade Methods illustrate the three different ways by which you can upgrade or downgrade a security device.
