Juniper Networks ScreenOS Release Notes

Products: NetScreen Hardware Security Client (HSC), NetScreen-5GT Series, NetScreen-25, NetScreen-50, NetScreen-200 Series, NetScreen-500, Integrated Security Gateway (ISG) 1000, ISG 1000-IDP, ISG 2000, ISG 2000-IDP, Secure Services Gateway (SSG) 5, SSG 20, SSG 140, SSG 500 Series, and NetScreen-5000 Series.

Version: ScreenOS 5.4.0r3

Date: February 20, 2007

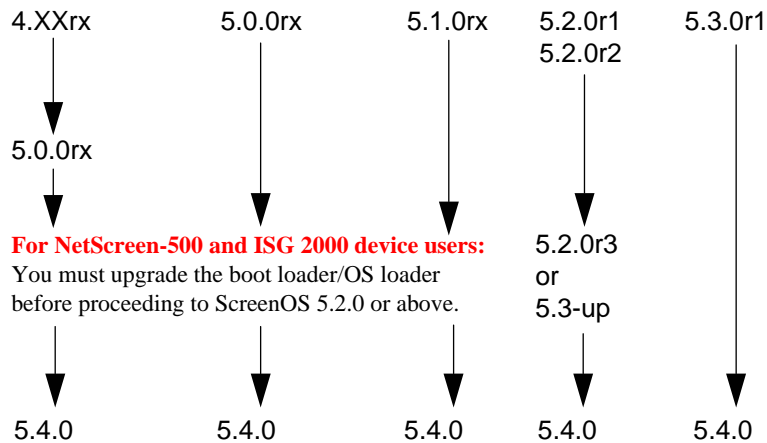
Figure 1. Firmware Upgrade Path

Before you upgrade a security device, you must have the most recent ScreenOS firmware stored on your local drive. Depending on the platform and the firmware your security device is currently running, you also might need intermediate (or step-up) firmware and/or new bootloader firmware. Firmware Upgrade Path illustrates the various firmware upgrade paths to ScreenOS 5.4.0.

Figure 1 lists the recommended upgrade path to ScreenOS 5.4.0 based on device model and firmware version. For example, if you are running ScreenOS 4.0 on a NetScreen-204, you need to upgrade to ScreenOS 5.0r10 or later before upgrading to ScreenOS 5.4.0. If you are running ScreenOS 5.1 on a NetScreen-204, however, you can upgrade directly to 5.4.0. Upgrade Paths to ScreenOS 5.4.0 also lists memory and boot loader upgrade requirements for each ScreenOS version and platform.
