# Juniper Networks ScreenOS Release Notes

Release 5.4.0r20 March 2011 Revision 01

**Products:** NetScreen-5GT Series, NetScreen-25, NetScreen-50, NetScreen-200 Series, NetScreen-500, and NetScreen-5000 Series (NetScreen-5200 and NetScreen-5400 with MGT or MGT2 modules and 2G24FE or 8G SPM).

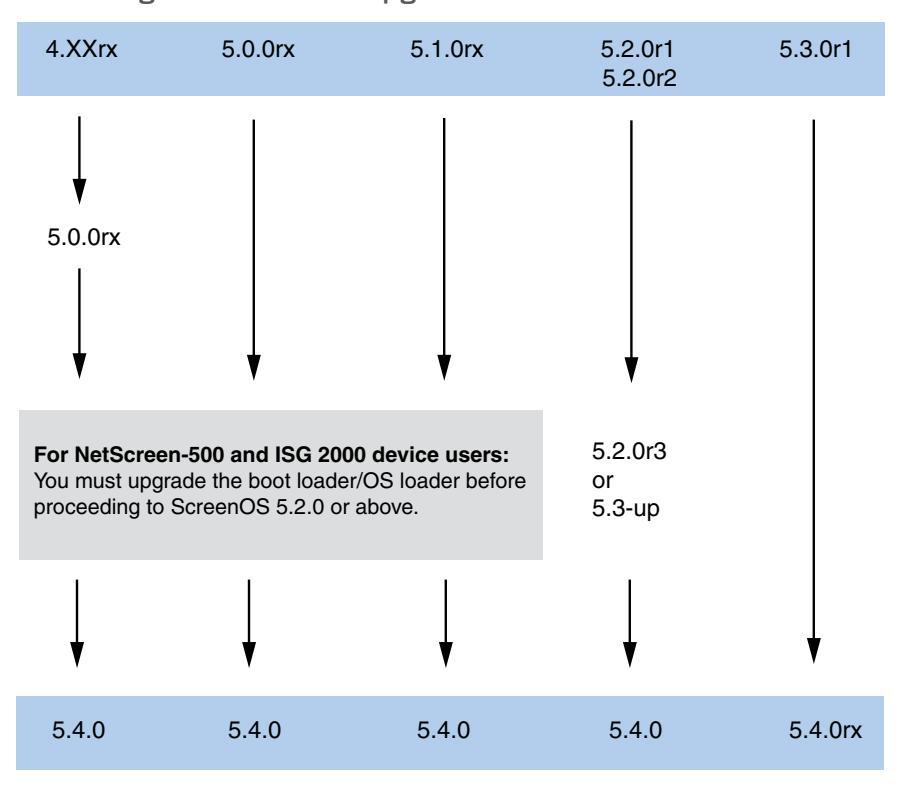
Figure 1: Firmware Upgrade Path

Figure 1 on page 20 lists the recommended upgrade path to ScreenOS 5.4.0 based on device model and firmware version. For example, if you are running ScreenOS 4.0 on a NetScreen-204, you need to upgrade to ScreenOS 5.0r10 or later before upgrading to ScreenOS 5.4.0. If you are running ScreenOS 5.1 on a NetScreen-204, however, you can upgrade directly to 5.4.0. Upgrade Paths to ScreenOS 5.4.0 also lists memory and boot loader upgrade requirements for each ScreenOS version and platform.

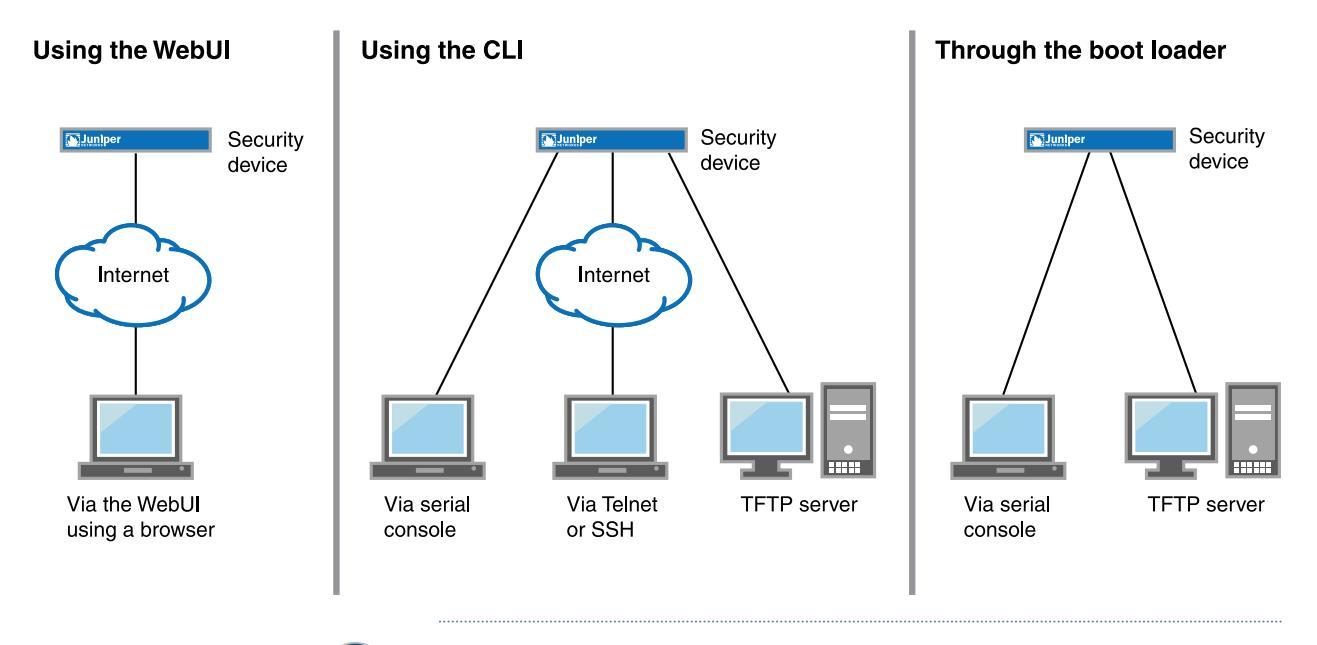
ScreenOS Upgrade and Downgrade Methods illustrate the three different ways by which you can upgrade or downgrade a security device.
